# On site renovation of degraded PV panels – Cost and environmental effective technology

Vladislav Poulek<sup>a</sup>, Igor Tyukhov<sup>b,\*</sup>, Vaclav Beranek<sup>c</sup>

<https://doi.org/10.1016/j.solener.2023.111956>

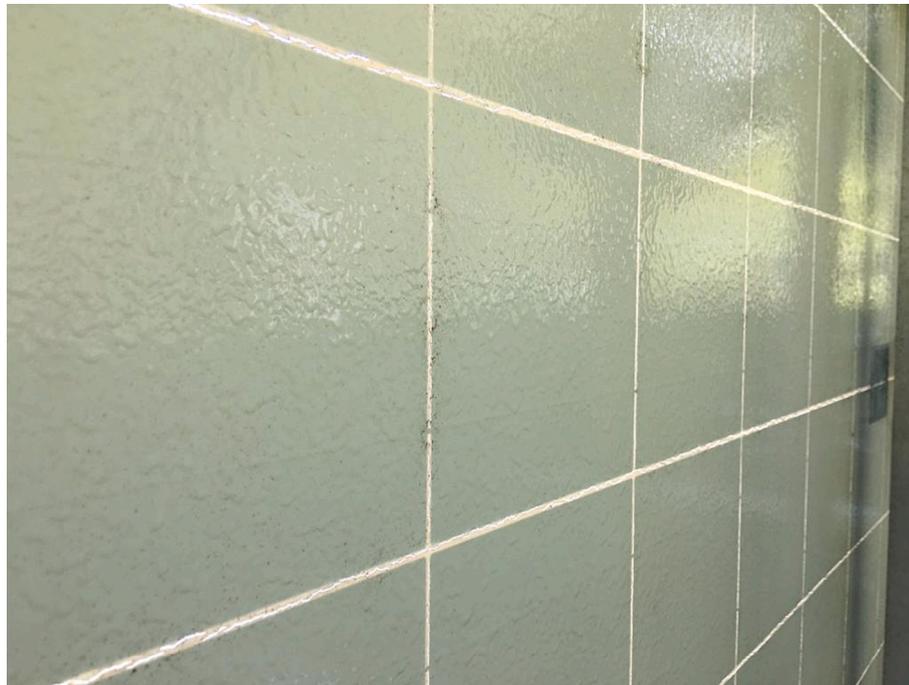
**Fig. 1.** Picture of renovation PDMS film on back side of PV panel.

We have developed a new PV panel renovation process that includes not only on-site thin 0.1 mm PDMS film deposition technology but also a comprehensive on-site PV panel diagnosis, including measurements of ground impedance (Risol), delamination, and other factors, both before and after the protective film deposition. The two component PDMS has been deposited on site by spraying method. Fast cure (30 min at temperature 25°Celsius) PDMS was used. The film thickness was measured by micrometer gauge. The main method to check the renovation film quality has been regular testing of ground impedance (Risol) in real field (wet) conditions. To double check the renovation quality early morning inverter switch on time was monitored. Once there are troubles with low Risol the inverters are switched on several hours later as the inverters have internal Risol safety control [1]. Besides Risol tests visual check of chalking and edge delamination was performed.

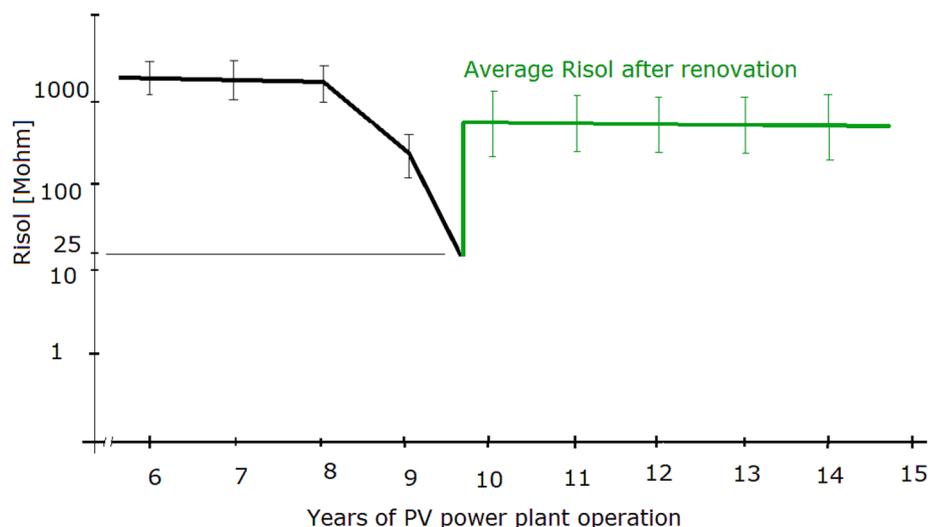
**Fig. 2.** Real field (wet) Risol of PV panels before and after PV panel renovation.

To evaluate the effectiveness of our renovation process, we selected two test sets comprising 40 first-tier (bankable) PV panels rated at 250 W each. These panels were installed at a 2 MW PV power plant situated in a moderate climate region of central Europe. The first set consisted of damaged PV panels that were repaired using a 0.1 mm thin PDMS film with fast curing properties. The repaired panels were observed for a period of 5 years. As shown in Fig. 2, the real-field (wet) PV panel ground impedance (Risol) was successfully restored after the renovation and remained nearly unchanged throughout the 5-year observation period.

The tests demonstrate that the lifetime of repaired PV panels could be extended by 5 years or even more. The low cost renovation can be performed repeatedly in 5–7 years period. In contrast, the second set of PV panels without renovation experienced significant degradation after 5 years, leading to non-repairable failure. This failure was characterized by the presence of electric discharge channels between the PV panel's internal busbars and the grounded PV panel frame (Fig. 3), with Risol values falling below the critical threshold of 25 Mohm. At the beginning of the test (10 years of operation) Risol of 18 panels was below 25Mohm. At the end of the test (15 years of operation) Risol of all 40 PV panels was well below 25Mohm. Furthermore, delamination of the panel edges occurred, allowing water penetration and degradation of the back-surface laminate, resulting in cracks and chalking. It is crucial to conduct PV panel renovation within approximately one year after a rapid decrease in Risol is observed. Once an electric discharge channel is formed, the PV panel becomes irreparable. To date, a total of 41 MW of PV panels have been successfully repaired using the thin siloxane film method.

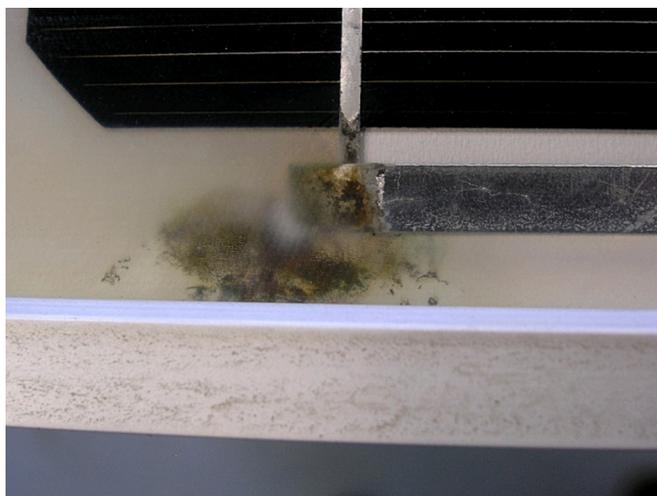
**Fig. 3.** Discharge channel between internal solar panel busbar and grounded PV panel frame.
